Location:
**Hutton Rudby
Parish Council Survey**

Report Type:
Arboricultural Condition Survey

Ref:
ARB/CP/2635

Date:
March 2023

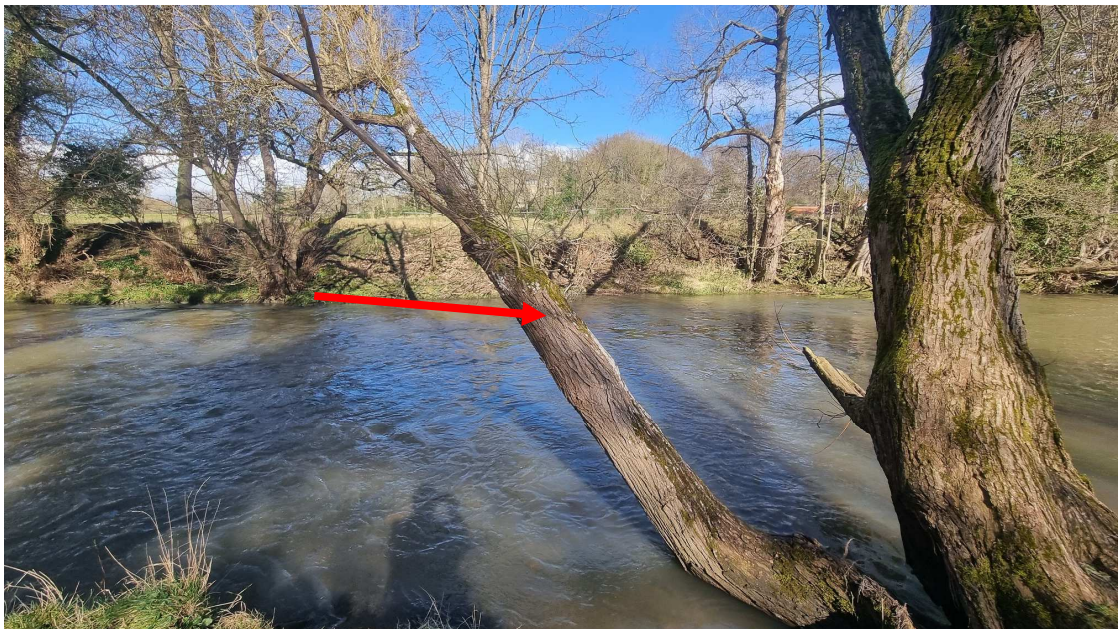
- 4.7 Tree 74 is a mature Willow on the riverbank at the Linen Mill. It has two stems emanating from the base, one of which has failed (refer to Photo 1). As this section of the tree failed it became entangled, or hung-up, in the canopy of a tree on the opposite side of the river. The stem is still partially attached to the roots, but this could potentially be severed in a flood event. Additionally, the lower section of the failed stem can easily be accessed from the riverbank, which presents a possible safety issue. It would be expedient to consult a contractor to determine how feasible it would be to remove this stem.

Photo 1: Willow with failed stem (red arrow)
